CYCLONE TESTING STATION

REPORT NO. TS1083

Serviceability and Static Simulated Racking Strength Testing of Moroblock Wall System

E-Abode Pty Ltd

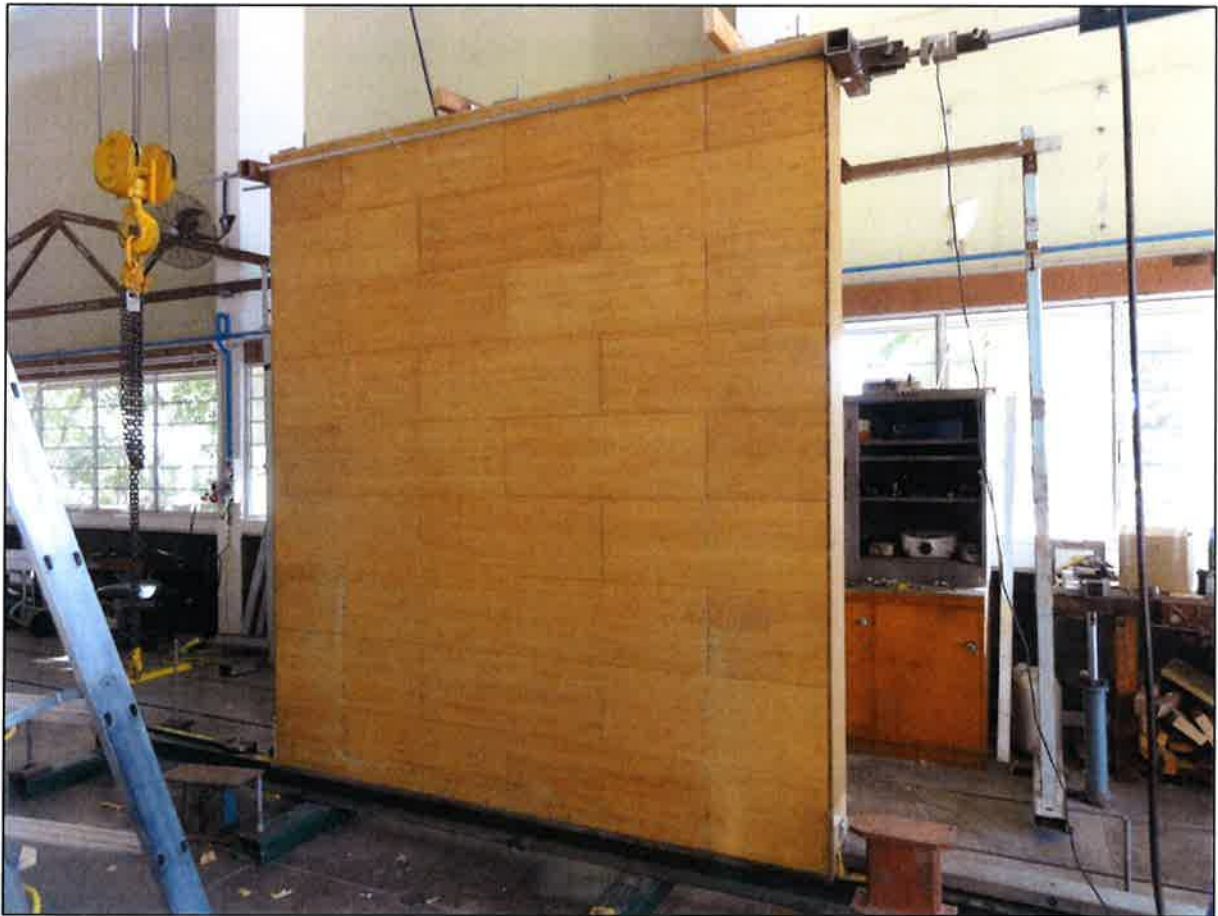
The wall spacers for *Wall 1* were stated to have been manufactured in a way that the fibre orientation of the outer skins of the wall spacers were running horizontally in respect to the whole wall.

Figure 1 shows *Wall 1* constructed with the *Moroblock* system and Figure 2 shows *Wall 2* constructed with the *Moroblock* system.

Figure 1: *Moroblock* Wall System Sample (Wall 1)

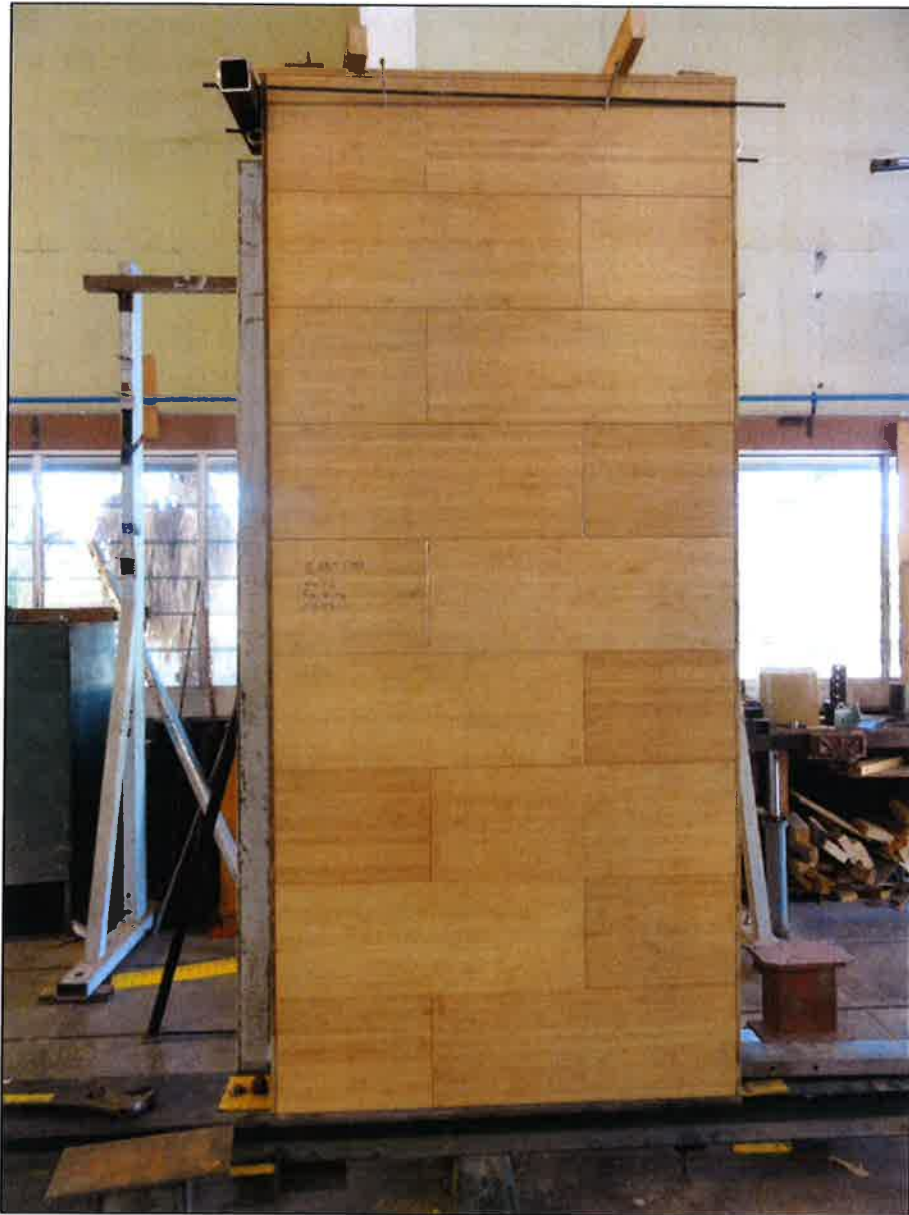
The wall spacers for *Wall 2* were stated to have been manufactured in a way that the fibre orientation of the outer skins of the wall spacers were running vertically in respect to the whole wall.

Figure 2: Moroblock Wall System Sample (Wall 2)

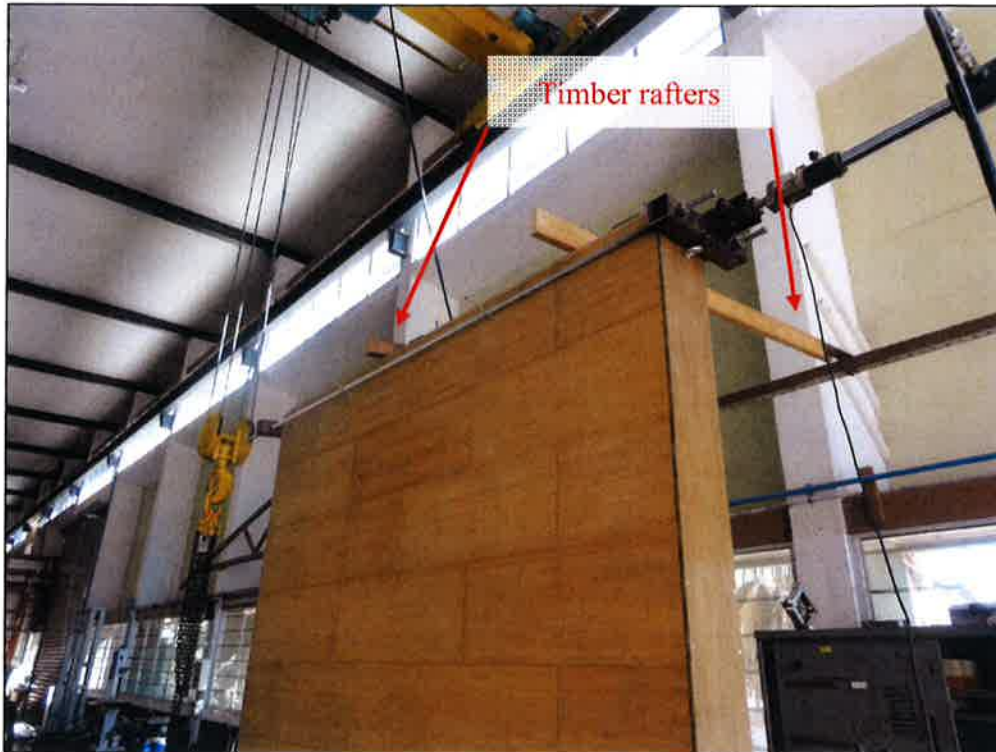
To ensure the wall remained in vertical position, two timber rafters were fixed to the top plate and attached to a supporting frame, which was fixed to the concrete structural floor. The timber rafters were free to rotate at their attachment points with the supporting frame to minimize their effects on the test results. Figure 5 shows the location of the timber rafters.

Figure 5: Sample Maintained in Vertical Position thanks to Timber Rafters

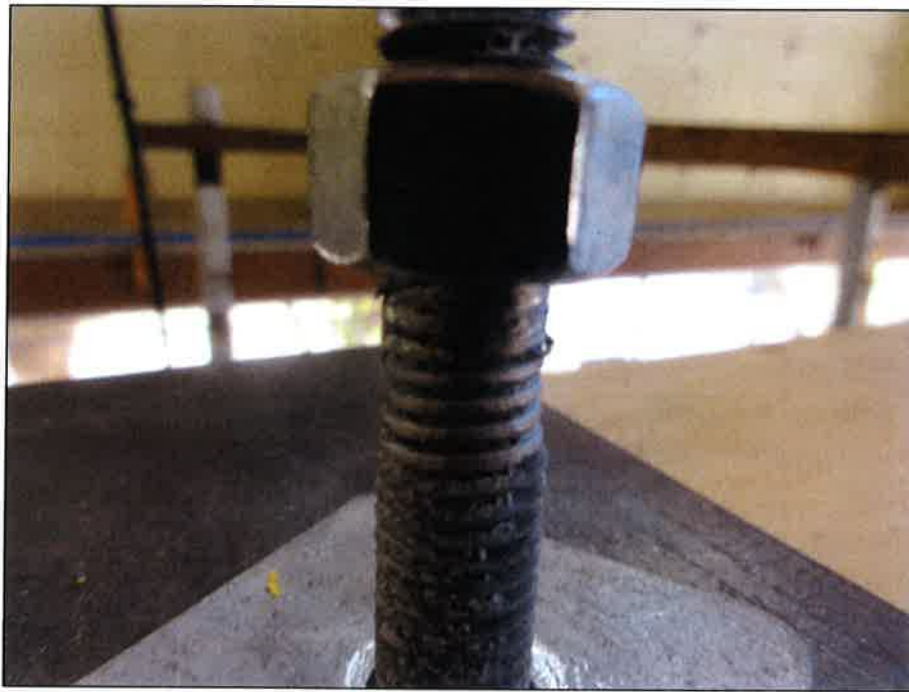
Figure 6: Photograph of Tie-Down Rod after Failure

Wall No.	Trial No.	Date Tested	Failure (Maximum) Load supported (kN)	Comments on Failure
Wall 1	SS1	8 Aug 2017	36.09	Failure of tie down rod. From noise and slight movement during the test, the tie down rod thread may have been slipping from approximately 23 kN.
Wall 2	SS2	8 Aug 2017	14.35	Failure of tie down rod
